**Flood Control Project Maintenance  
Levee Inspections**

**Fall 2018 Levee Maintenance Deficiency Summary Report**

**Sutter Maintenance Yard Maintenance Area 0016**

Waterway			Bank	Unit Miles
Unit No. 01 Feather River			Right	4.06
	Spring (March - May)	Summer (June - August)	(September - November) Fall	Winter (December - February)
Unit Maintenance Rating (Fall Only)			<b>A</b>	
Date of Inspection	3/20/2018 - 3/20/2018		9/6/2018 - 9/6/2018	
DWR Inspector	Sterling York		Sterling York	
Accompanied By	Shawn Freitag Sutter Maintenance Yard		Shawn Freitag Sutter Maintenance Yard

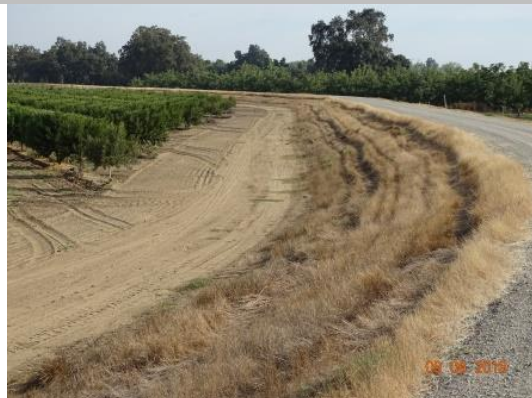
Photo 1 of 1 : FA\_2018\_MA0016\_302\_6\_20181002\_00009.jpg

LM Start	0.00	Rating **	A	Issue No.	6
LM End	4.07	Issue Type +	Ma	Location *	LS
Category	Earthen Levee			GPS Latitude/Longitude	
				Start	End
Item	Vegetation			39.255795 °	39.311097 °
				-121.636396 °	-121.637631 °
DWR ID	DWR_MA0016_01_f_2018_6				
Comment Code					
V1 : Control annual grass and weeds on the levee slopes and easements.					
Inspector Comment					
The annual vegetation is well maintained, Fall 2018.

View looking upstream landside at the well maintained annual vegetation, Fall 2018.

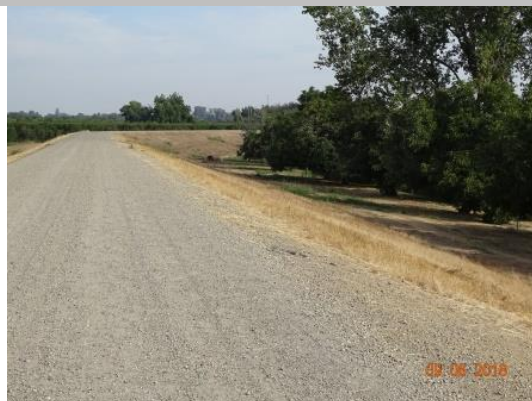
Photo 1 of 1 : FA\_2018\_MA0016\_302\_7\_20181002\_00008.jpg

LM Start	0.00	Rating **	A	Issue No.	7
LM End	4.07	Issue Type +	Ma	Location *	WS
Category	Earthen Levee			GPS Latitude/Longitude	
				Start	End
Item	Vegetation			39.255795 °	39.311097 °
				-121.636396 °	-121.637631 °
DWR ID	DWR_MA0016_01_f_2018_7				
Comment Code					
V1 : Control annual grass and weeds on the levee slopes and easements.					
Inspector Comment					
The annual vegetation is well maintained, Fall 2018.

View looking upstream waterside at the well maintained annual vegetation, Fall 2018.

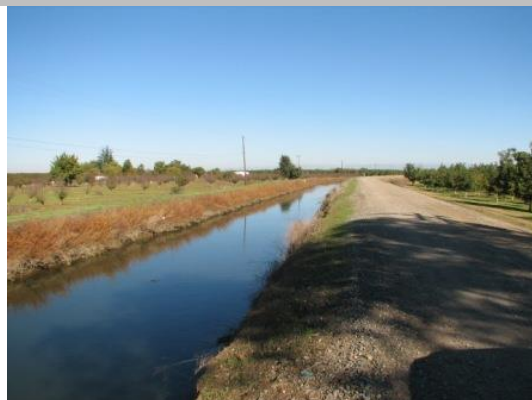
Photo 1 of 2 : FA\_2018\_MA0016\_302\_14\_20180906\_00002.jpg

LM Start	2.85	Rating **	M	Issue No.	14
LM End	3.08	Issue Type +	En	Location *	LS
Category	Earthen Levee			GPS Latitude/Longitude	
				Start	End
Item	Encroachments			39.293675 °	39.296748 °
				-121.636615 °	-121.638192 °
DWR ID	DWR_MA0016_01_s_2012_14				
Comment Code					
DT : Ditch					
Inspector Comment					
Agricultural ditch land side slope and toe.

Agricultural ditch land side slope and toe.

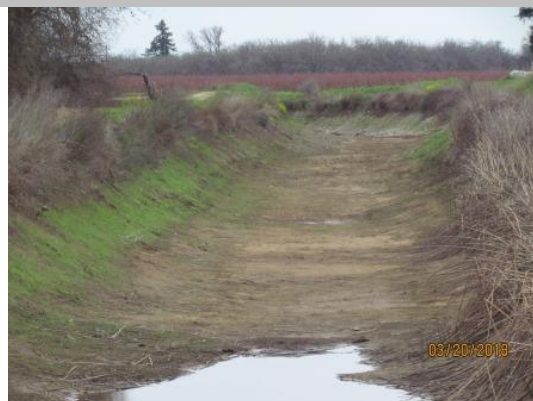
Photo 2 of 2 : FA\_2018\_MA0016\_302\_14\_20180906\_00003.jpg

LM Start	2.85	Rating **	M	Issue No.	14 (cont)	
LM End	3.08	Issue Type +	En	Location *	LS	
Category	Earthen Levee			GPS Latitude/Longitude		
				Start	End	
Item	Encroachments			39.293675 °	39.296748 °	
				-121.636615 °	-121.638192 °	
DWR ID	DWR_MA0016_01_s_2012_14					
Comment Code						
DT : Ditch						
Inspector Comment						
Agricultural ditch land side slope and toe.

Agricultural ditch land side slope and toe.

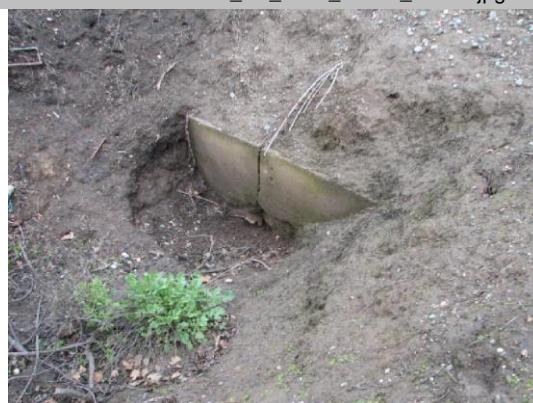
Photo 1 of 2 : UCIP\_FA\_2018\_51931\_65782.jpg

Comment Code						
Inspector Comment						
FS_ID:51931 DS_ID:17125 EP_NO: N/A Repair Type: Non-Urgent Crossing Status: Found UCIP Comments: 5/22/2017 LS inlet buried. WS access being blocked off by over grown vegetation. Pipe has been selected for internal cleaning and inspection as part of the DMP project. (DWR Sutter Yard - AFreitag)12/1/2016 LS inlet completely buried. (DWR Sutter Yard - AFreitag)5/26/2016 LS inlet was completely buried.6/8/2015 Concrete headwall is still cracked and inlet is buried. It was said to be replaced with the SBFCA project but the project skipped over in this area.12/29/2014 Same as last inspection.5/19/2014 Same as last inspection.11/6/2013 Same as last inspection.5/14/2013 SBFCA project recommends replacing in accordance with title 23. Same as last inspection.12/11/2012 Concrete headwall on LS toe is cracked through middle and pipe is burried in soil. pipe appears corroded. (DWR UCIP - W. Wylie) FIELD_STRUCT_DESC: 1 of 2: 24-inch corrugated metal drainage pipe through the levee, 16.6 feet below the crown. Concrete headwalls on both the waterside (WS) and the landside (LS) ends. Flap gate on the WS end. [Additional Reference(s): DWR Levee Log, 2005. USACE Sacramento O&M Manual 148, August 1955, (Station 646+96)]. FS Date: 5/31/2017 7:29:38 AM

Headwall at LS toe is cracked and the inlet is buried in soil.

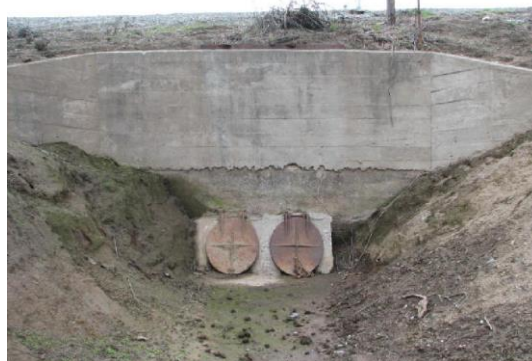
Photo 2 of 2 : UCIP\_FA\_2018\_51931\_65781.jpg

Comment Code						
Inspector Comment						
FS_ID:51931 DS_ID:17125 EP_NO: N/A Repair Type: Non-Urgent Crossing Status: Found UCIP Comments: 5/22/2017 LS inlet buried. WS access being blocked off by over grown vegetation. Pipe has been selected for internal cleaning and inspection as part of the DMP project. (DWR Sutter Yard - A Freitag)12/1/2016 LS inlet completely buried. (DWR Sutter Yard - A Freitag)5/26/2016 LS inlet was completely buried.6/8/2015 Concrete headwall is still cracked and inlet is buried. It was said to be replaced with the SBFCA project but the project skipped over in this area.12/29/2014 Same as last inspection.5/19/2014 Same as last inspection.11/6/2013 Same as last inspection.5/14/2013 SBFCA project recommends replacing in accordance with title 23. Same as last inspection.12/11/2012 Concrete headwall on LS toe is cracked through middle and pipe is burried in soil. pipe appears corroded. (DWR UCIP - W. Wylie) FIELD_STRUCT_DESC: 1 of 2: 24-inch corrugated metal drainage pipe through the levee, 16.6 feet below the crown. Concrete headwalls on both the waterside (WS) and the landside (LS) ends. Flap gate on the WS end. [Additional Reference(s): DWR Levee Log, 2005. USACE Sacramento O&M Manual 148, August 1955, (Station 646+96)]. FS Date: 5/31/2017 7:29:38 AM

Headwall on WS toe with flap gates.

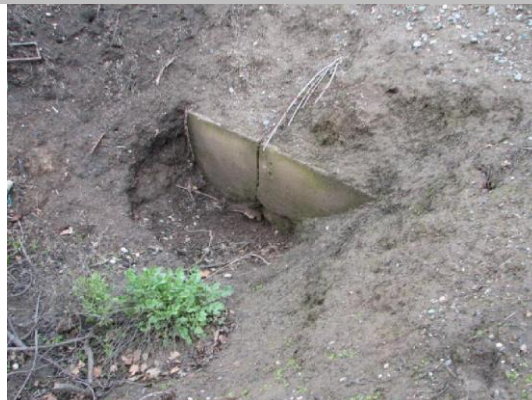
Photo 1 of 2 : UCIP\_FA\_2018\_51932\_65780.jpg

FS\_ID:51932  
DS\_ID:17183  
EP\_NO: N/A  
Repair Type: Non-Urgent  
Crossing Status: Indicator Found  
UCIP Comments: 5/22/2017 LS inlet is buried. WS access is being blocked off by overgrown vegetation. (DWR Sutter Yard - A Freitag) 12/1/2016 LS inlet is completely buried. (DWR Sutter Yard - A Freitag) 5/26/2016 LS inlet was completely buried. 6/8/2015 Concrete headwall is still cracked and inlet is buried. It was said to be replaced with the SBFA project but the project skipped over in this area. 12/29/2014 Same as last inspection. 5/19/2014 Same as last inspection. 11/6/2013 Same as last inspection. 5/14/2013 SBFA project recommends replacing in accordance with title 23. Same as last inspection. 12/11/2012 Pipe buried on LS toe and should be inspected along with adjacent 24-inch once uncovered. (DWR UCIP - W. Wylie) FIELD\_STRUCT\_DESC: 2 of 2: 24-inch corrugated metal drainage pipe through the levee, 16.6 feet below the crown. Headwalls at both the waterside (WS) and landside (LS) ends and a flap gate on the WS toe. [Additional Reference(s): DWR Levee Log, 2005. USACE Sacramento O&M Manual 148, August 1955 (Station 646+96)].

Pipe should be located on either side of the one visible in this picture.

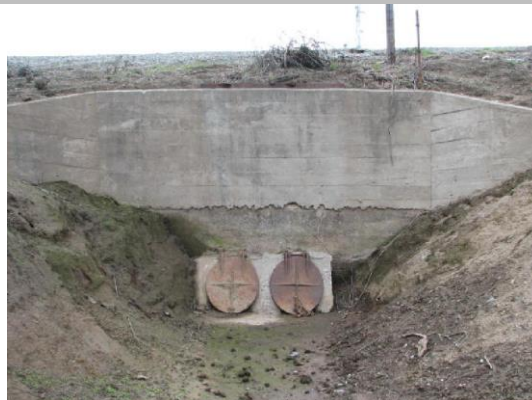
Photo 2 of 2 : UCIP\_FA\_2018\_51932\_65779.jpg

Headwall and flap gate on WS toe.

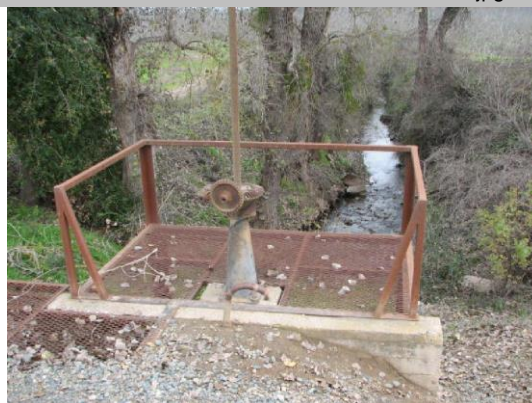
Photo 1 of 3 : UCIP\_FA\_2018\_52886\_65785.jpg

Comment Code					
Inspector Comment					
FS_ID:52886 DS_ID:17123 EP_NO: N/A Repair Type: No Action Needed Crossing Status: Found UCIP Comments: 5/22/2017 Crossing appears to be in good condition. (DWR Sutter Yard - A/Freitag)12/1/2016 Crossing appears to be in good condition. (DWR Sutter Yard- A/Freitag)5/26/2016 Crossing appears to be in good condition.6/8/2015 Pipe appears to be in good condition. No noticeable issues to report. Pipe was listed to be replaced with the SBFCA project but the project did not take place in this area.12/29/2014 Same as last inspection.5/19/2014 Same as last inspection.11/6/2013 Same as last inspection.5/14/2013 Slide gate opened allowing water to flow through, debris problem has been cleared and the gates seem to be functioning properly. SBFCA project recommends replacing in accordance with title 23.12/11/2012 Lock missing from concrete well access door-this should be resplaced. Some debris blocking preventing flapgate from completely closing. (DWR UCIP - W. Wylie) FIELD_STRUCT_DESC: 48-inch by 72-inch reinforced concrete drainage culvert through the levee, 20.5 feet below the crown. Slide gate in a concrete well on the waterside (WS) slope. Siphon breaker/air vent on the WS shoulder at the concrete well. [Additional Reference(s): DWR Levee Log, 2005. USACE Sacramento O&M Manual 148, August 1955, (Station 683+25)]. FS Date: 5/31/2017 7:36:00 AM

Slide gate, concrete well, siphon breaker/air vent and open channel on WS of levee.

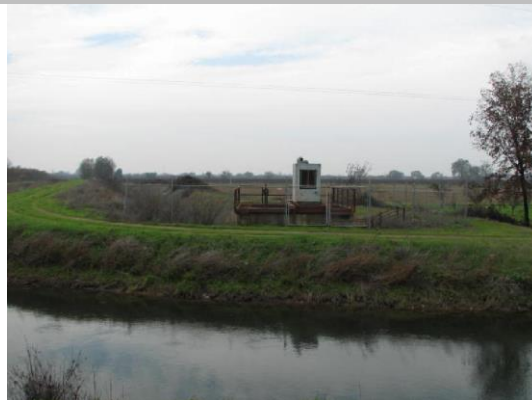
Photo 2 of 3 : UCIP\_FA\_2018\_52886\_65784.jpg

Comment Code					
Inspector Comment					
FS_ID:52886 DS_ID:17123 EP_NO: N/A Repair Type: No Action Needed Crossing Status: Found UCIP Comments: 5/22/2017 Crossing appears to be in good condition. (DWR Sutter Yard- A Freitag)12/1/2016 Crossing appears to be in good condition. (DWR Sutter Yard- A Freitag)5/26/2016 Crossing appears to be in good condition.6/8/2015 Pipe appears to be in good condition. No noticeable issues to report. Pipe was listed to be replaced with the SBFCA project but the project did not take place in this area.12/29/2014 Same as last inspection.5/19/2014 Same as last inspection.11/6/2013 Same as last inspection.5/14/2013 Slide gate opened allowing water to flow through, debris problem has been cleared and the gates seem to be functioning properly. SBFCA project recommends replacing in accordance with title 23.12/11/2012 Lock missing from concrete well access door-this should be resplaced. Some debris blocking preventing flapgate from completely closing. (DWR UCIP - W. Wylie) FIELD_STRUCT_DESC: 48-inch by 72-inch reinforced concrete drainage culvert through the levee, 20.5 feet below the crown. Slide gate in a concrete well on the waterside (WS) slope. Siphon breaker/air vent on the WS shoulder at the concrete well. [Additional Reference(s): DWR Levee Log, 2005. USACE Sacramento O&M Manual 148, August 1955, (Station 683+25)]. FS Date: 5/31/2017 7:36:00 AM

Pumping plant and slide gate on LS accross canal. (no access from levee).

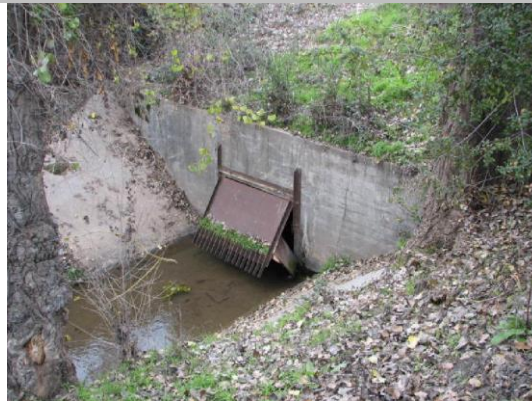
Photo 3 of 3 : UCIP\_FA\_2018\_52886\_65783.jpg

Concrete headwall and flap gate on WS toe.
